**SERVICE BULLETIN
B43573-1-35-001**

ATA SYSTEM: 35

**TITLE: EMERGENCY PASSENGER OXYGEN SYSTEM ADDITION OF
BRACKET TO STRENGTHEN THE HAND VALVE / REDUCER
STRUCTURAL INTERFACE**

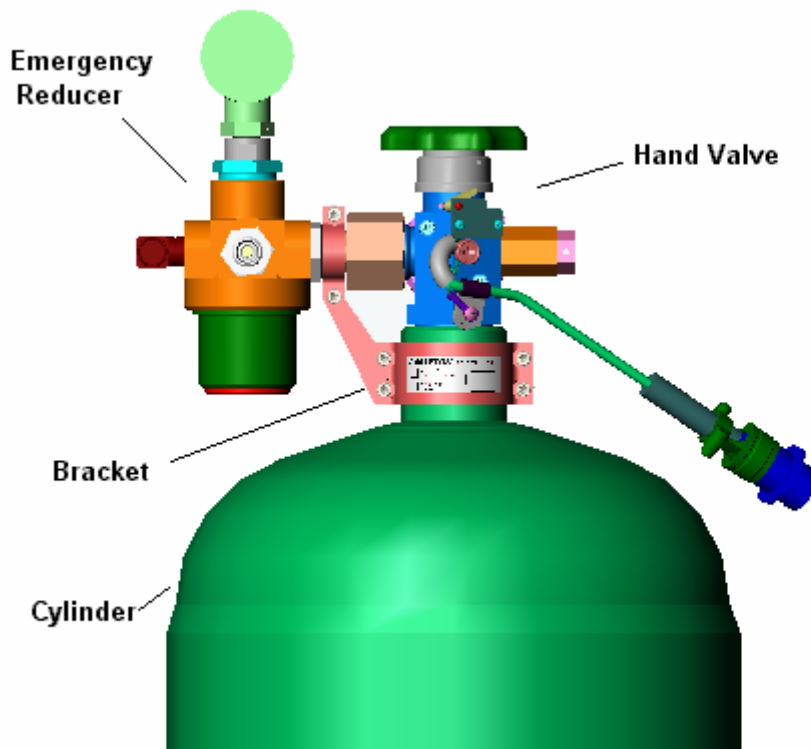
Figure 1

The Emergency Reducer assembly is attached by a CGA inlet fitting to the Cylinder and Hand Valve Assembly (see Fig 1). The Hand Valve is equipped with a brass CGA outlet fitting. Vibration testing conducted at Carleton Technologies, Inc. (the manufacturer of the Hand Valve, and Emergency Reducer), indicates that installations of this hardware configuration without rigid mounting of the Reducer to the airframe will result in a concentration of stress on the outlet threads of the Hand Valve. This stress concentration could diminish the Hand Valve safety margin against structural failure under certain vibration conditions. The testing which revealed this potential problem was conducted at the Robust Random Vibration levels specified in RTCA/DO-160D.

Therefore, Carleton Technologies has designed a bracket (PN B44044-1) which stiffens and reinforces the structural interface between the Cylinder and Hand Valve Assembly and the Emergency Reducer Assembly.

The Bracket Assembly part number B44044-1 shall be installed around the structural interface between the Cylinder and Hand Valve assembly and the Emergency Reducer Assembly (as shown in Figure 1).
